Manhole Inspection Summary

Manhole # S33MM1007MH

Insp Date: **2/27/07 1:34 PM**

Location Address: **22 CHARLCOTE PL**

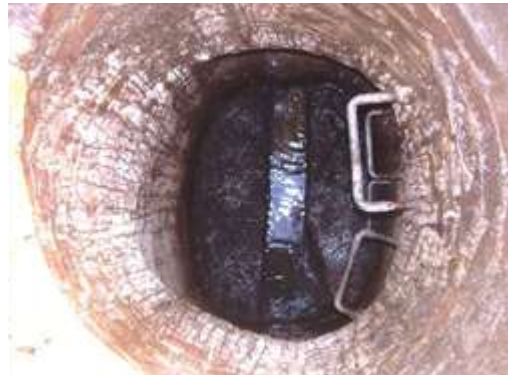
Top View

Evidence of surcharge - Bench debris.
Channel debris.

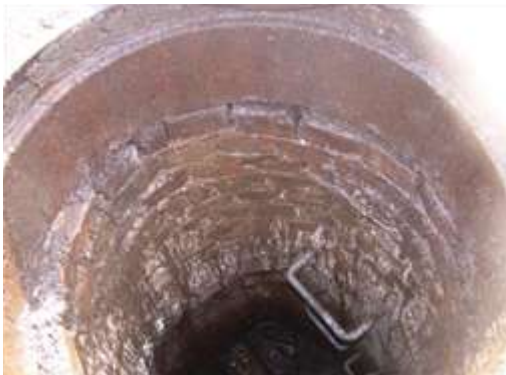
Defect

Frame leaks. Frame offset. Adjustment
deterioration and infiltration. Barrel
infiltration.

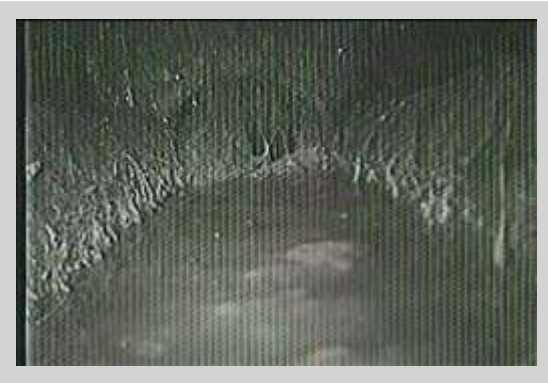
8 in. Circular Gravity Sewer Pipe Out @ 12 O'Clock

Channel root intrusion.

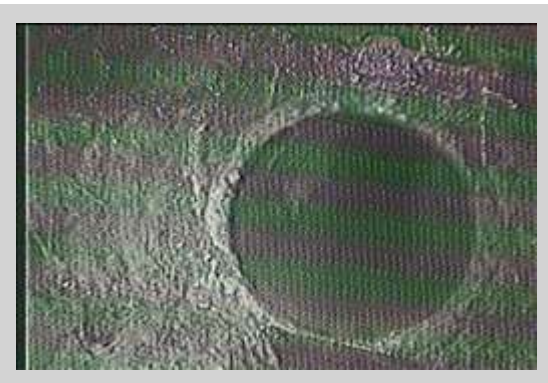
6 in. Circular Gravity Sewer Pipe In @ 5 O'Clock

Active infiltration above the pipe.
